02 and Up X-Type PCM

NUMBER
XT303-024
DATE
11 Sep 2006
MODEL
X-TYPE
SECTION:
303-00 - ENGINE SYSTEM

Engine Misfire or MIL Illumination with Possible DTCs Stored

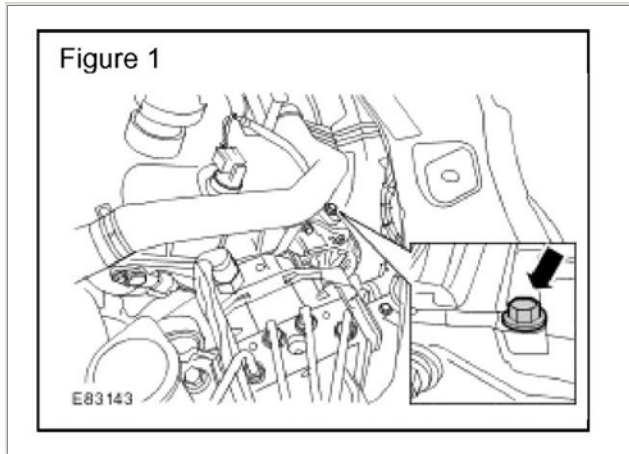
A customer may report a concern of an engine misfire or MIL illumination. Excessive glue on ground strap may be the cause.

2. Remove the ground strap bolt. (Figure 1)
3. Clean excessive glue from the ground strap.
4. Correctly seat the ground strap.
5. Install bolt to ground strap and tighten to 9Nm (6.5 lbf-ft).
