ALL BMW 98 AND NEWER

Tech Note

SI B 12 04 00
Engine Electrical Systems

SUBJECT
Secondary Air System Faults

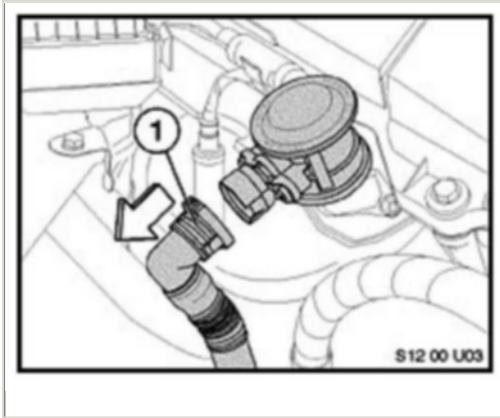
Disconnect the air pump feed line/hose (1) at the non-return valve (line from the secondary air pump

to the non-return valve).

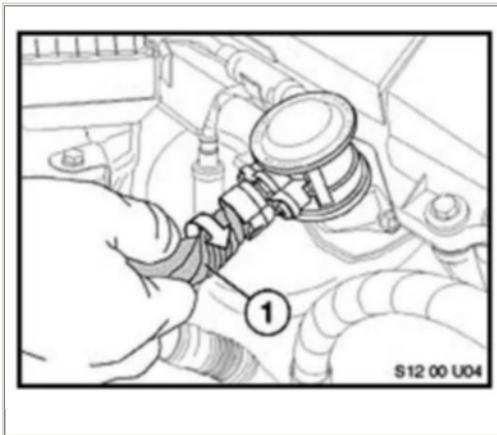
Visually inspect the non-return valve fitting internally for carbon type contamination. (Twisting the corner of a clean shop rag into the valve fitting as shown will assist with this check.)

If no carbon type deposits are found on the rag, this indicates that the non-return valve is sealing correctly and does not need to be replaced.

If carbon type deposits are found on the rag, the non-return valve is not sealing correctly and must be replaced.

A non-return valve which is not sealing correctly will cause damage to the secondary air pump as described above.

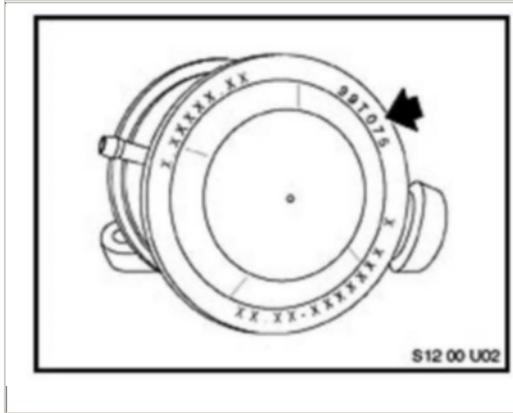
A Non-return valve with a dated code stamping as of 99T075 (arrow) and later is the improved version. date cose explanation: 99=year, T=day, 075=75th day of the year.

Only the improved non-return valves are available from the Parts Distribution Centers.
