SERVICE BULLETIN

EC09-010

June 12, 2009

2004 – 2005 ALTIMA; DTC P0420 WITH SULEV QR25DE ENGINE

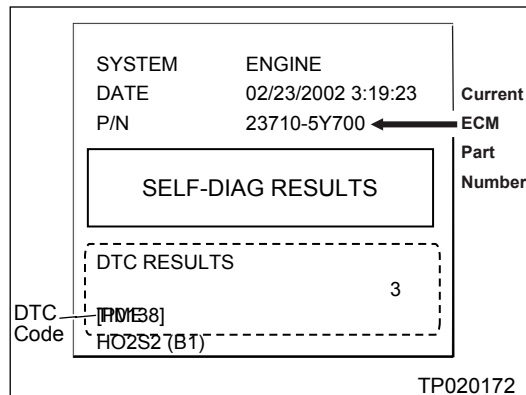
- Print out the CONSULT-II Self-Diagnosis results.
 - This print out will be used to check the ECM Part Number (determine if this bulletin applies).
 - Figure 1 is an example of the CONSULT-II Self-Diagnosis printout.

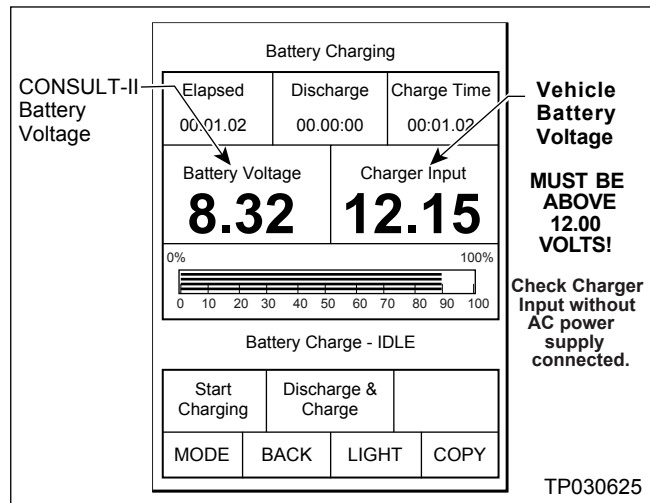
Figure D

- "Battery Voltage" is the voltage level of CONSULT-II's battery.
- "Charger Input" is the voltage level of the vehicle's battery. **(It must be above 12 volts.)**

3. Check the CONSULT-II's "Charger Input" reading (see Figure D).

CAUTION: If the "Charger Input" is below 12 volts:
