UNDERSTANDING FUEL TRIMS

UNDERSTANDING FUEL TRIM

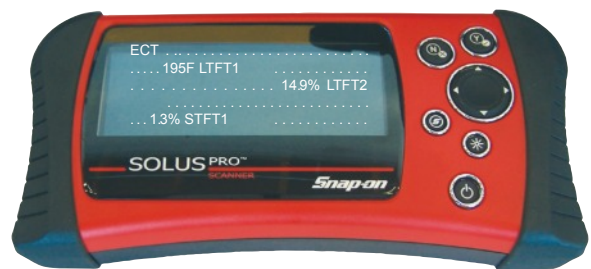
When adding the long term trim to the short term trim, we are obtaining a very basic "total trim number". This number should be close to zero, never exceeding 10% positive or negative, and ideally within 5%. For example, a LTFT of 3% and a STFT of 1% would give a total trim of 4% which is well within the normal range. Negative numbers can work in our favor as well, say the STFT is 4% and the LTFT is -2% the total trim number would be 2% which is near perfect. The same thing if the total trim number wound up in the negative, a number close to zero is fine, but 10% negative is out of limits for our purposes.

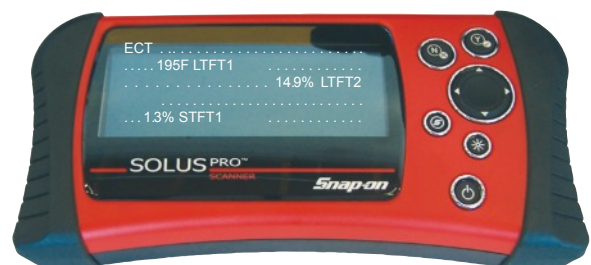
Now, there is *another* "rule of 10%" which can be an evil time waster. Besides the total trim value being well below the magic 10%, the spread between the long term and short term fuel trim values must be as well. As we said above, adding a negative number to a positive number can get you closer to zero which is a good thing, but if the spread is too large, we need to find out why. For example, LTFT is 7% and STFT is -7%, well that would give a total trim number of zero which is perfect, right? Not really.

The spread between the numbers is a whopping 14% which vastly exceeds the “rule”. Yes it’s true the total trim number is zero, but it’s a bad way of getting there. It is an indication that the PCM is not in complete control of the fuel injection, it’s scrambling to make up for an issue that is nearly out of its control. If the vehicle utilizes MAF, this condition STRONGLY suggests Mass Air Sensor issues. If the vehicle utilizes MAP, check the vacuum at the MAP sensor, etc. Of course there are other causes for this type of reading, but start with these common ones.
