SERVICE BULLETIN

Classification:	Reference:	Date
EC02-022	NTB02-092	September 5, 2002

'01MY FRONTIER AND XTERRA W/KA24, MIL "ON" DTC P0420 CATALYST

APPLIED VEHICLES: 2001 Frontier (D22)
2001 Xterra (WD22)
APPLIED ENGINE: KA24 (4 cylinder) ONLY

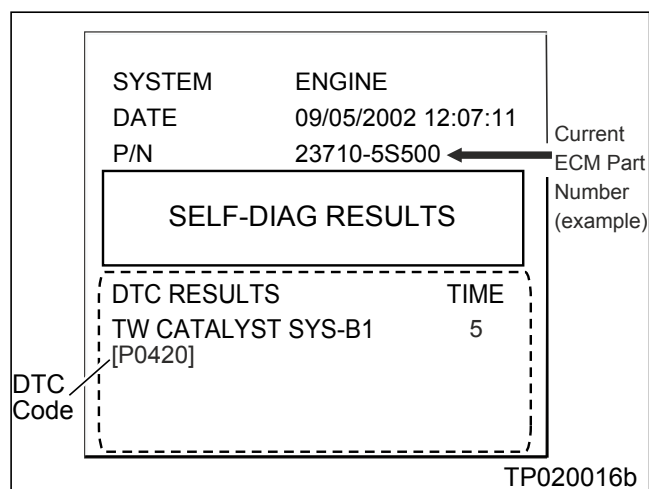
1. Determine which DTC code is stored in the vehicle's ECM by performing CONSULT-II Self-Diagnosis.
2. Print out the Self-Diagnosis results for use in **ECM Part Number Check**, below. See Figure 1 for an example of the CONSULT-II Self-Diagnosis printout.

1. Compare the vehicle's current ECM P/N (from your CONSULT-II Self Diagnosis printout) to those shown under **Current ECM P/N** in **Chart A**, below:
